STS-104/ET-109 Flight Readiness Review

External Tank Project

Cracks in ET-117 LH2 Barrel Panel Ribs

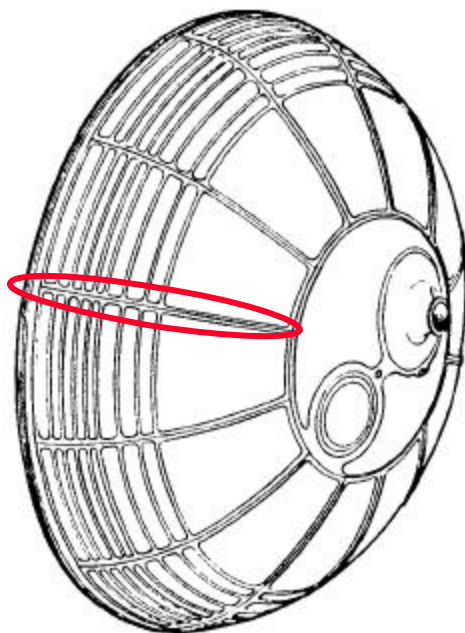
LO2 Tank Dome

- Non-standard initial weld of LO2 tank dome gore weld ODG-11 resulted in low weld elongation ($\approx 1.0\%$) which drove unique full length repair
 - No parameter violations were noted for any pass
 - Required use of standard 1" and wide panel (18") data to demonstrate repair weld properties

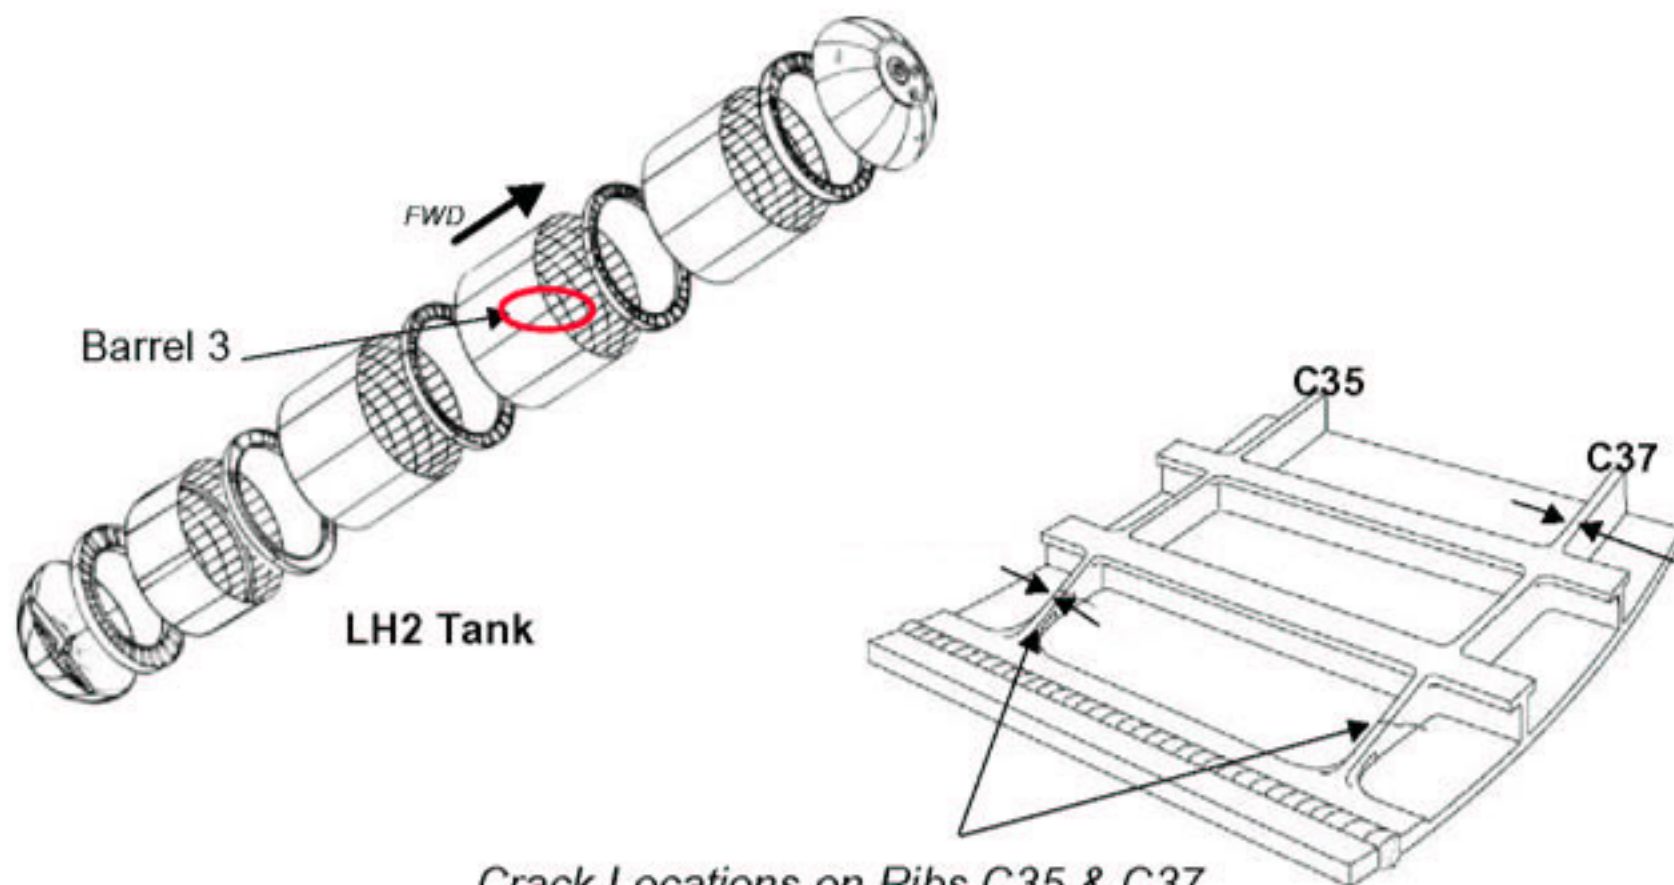
- Two cracks were found on LH2 Tank Barrel #3 during the first step of a planned post-proof visual inspection
 - The cracks were on two internal circumferential orthogrid ribs and went through the thickness of the rib and were approximately 1.00" long at the ISL (inner skin line)
 - ISL (inner skin line) observations
 - Cracks were similar in geometry
 - Indicates that ribs experienced similar stress condition
 - Cracks extended into the membrane
 - No other visible damage
 - OSL (outer skin line) observations
 - Dimple noted with visible indication at the rib (C37) location
 - Various minor scuff marks noted in the region of ribs C35 and C37

*Crack Locations on Ribs C35 & C37
Approx. 45° from +Z at Sta. 1400*

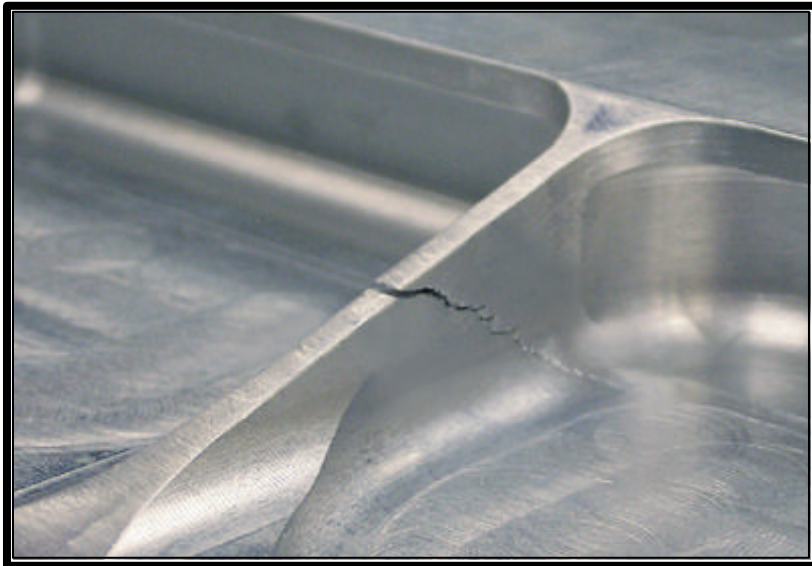
Crack on rib C35

- Latent Ingot/Plate Defect
 - Review of Reynolds Metals ultrasonic test showed no out-of-spec internal defects
 - Examination of C35 and C37 fracture faces showed no latent defects
- Incorrect Material Processing
 - Heat treat was correct
 - Records showed no out-of-family processing
 - Certification and witness panel results met strength requirements
 - Wet chemistry of sample from barrel panel was within specification requirements
 - Metallographic samples showed typical 2195-T8 microstructure
 - Strength and toughness
 - Tensile test coupons from barrel panel met requirements
 - Samples from ET-117 met the cryogenic simulated service test four mission life requirement
- Failure analysis of the two cracked ribs and surrounding area did not reveal any material anomalies
- ET-117 barrel panel material met all engineering requirements

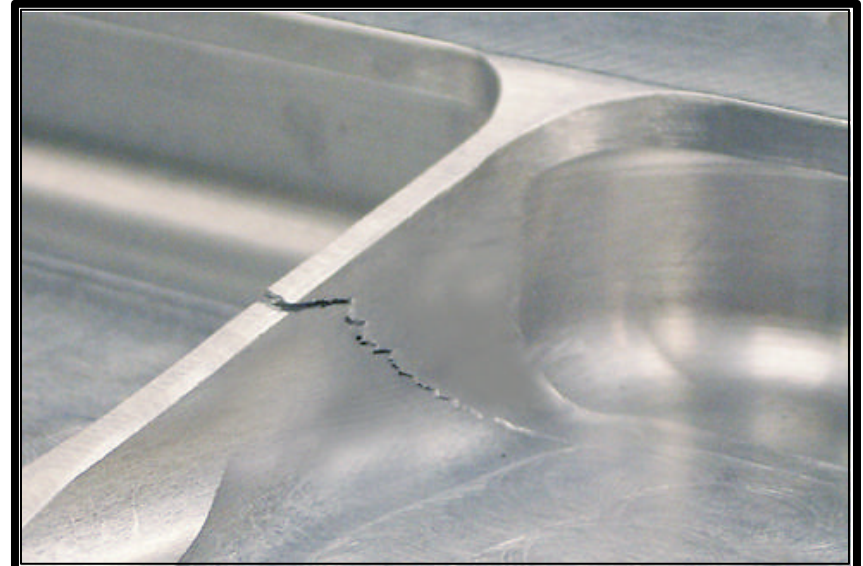
Crack on rib C37

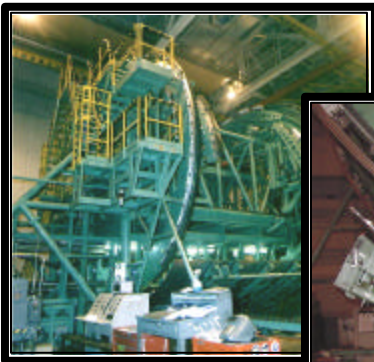
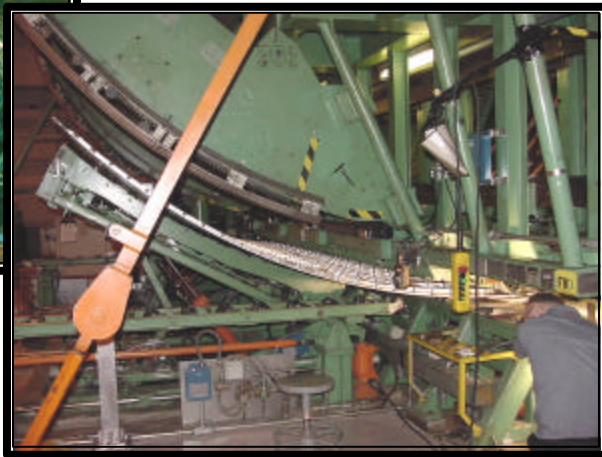
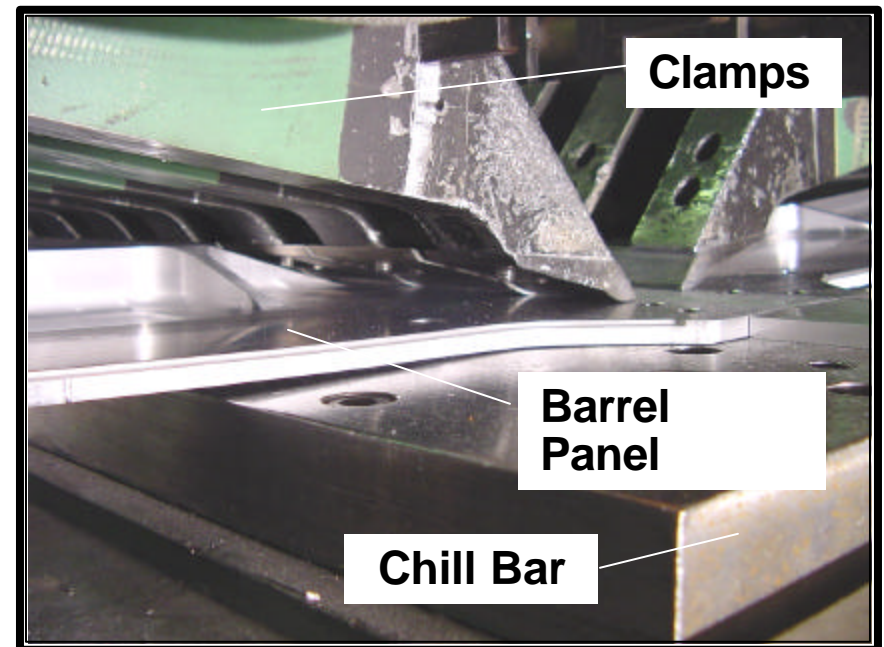
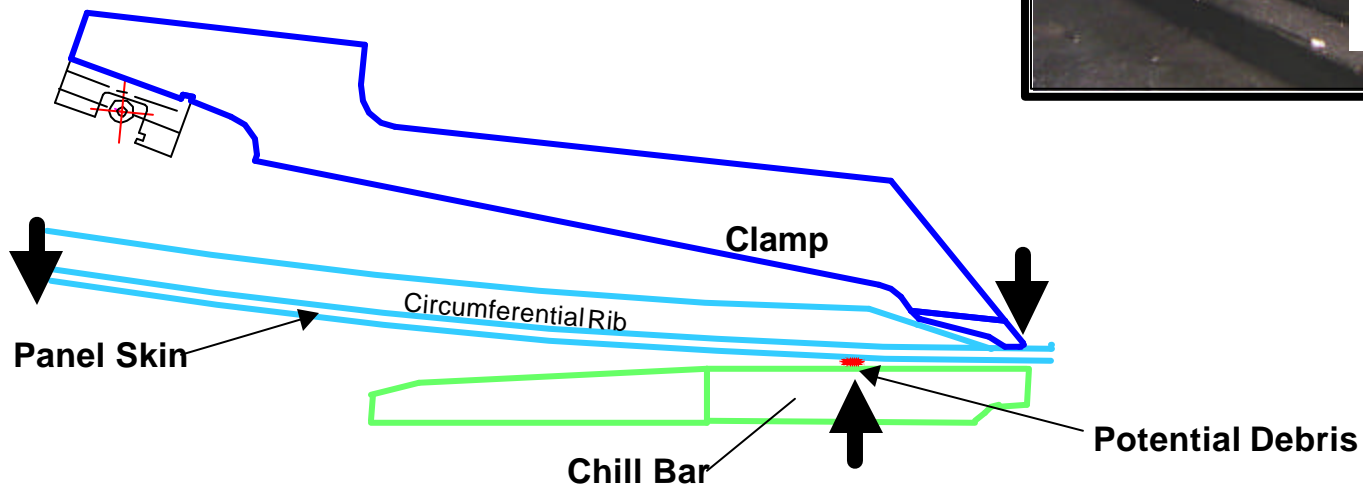
- Improper Clamping of Panel in Longitudinal Barrel Weld Tool

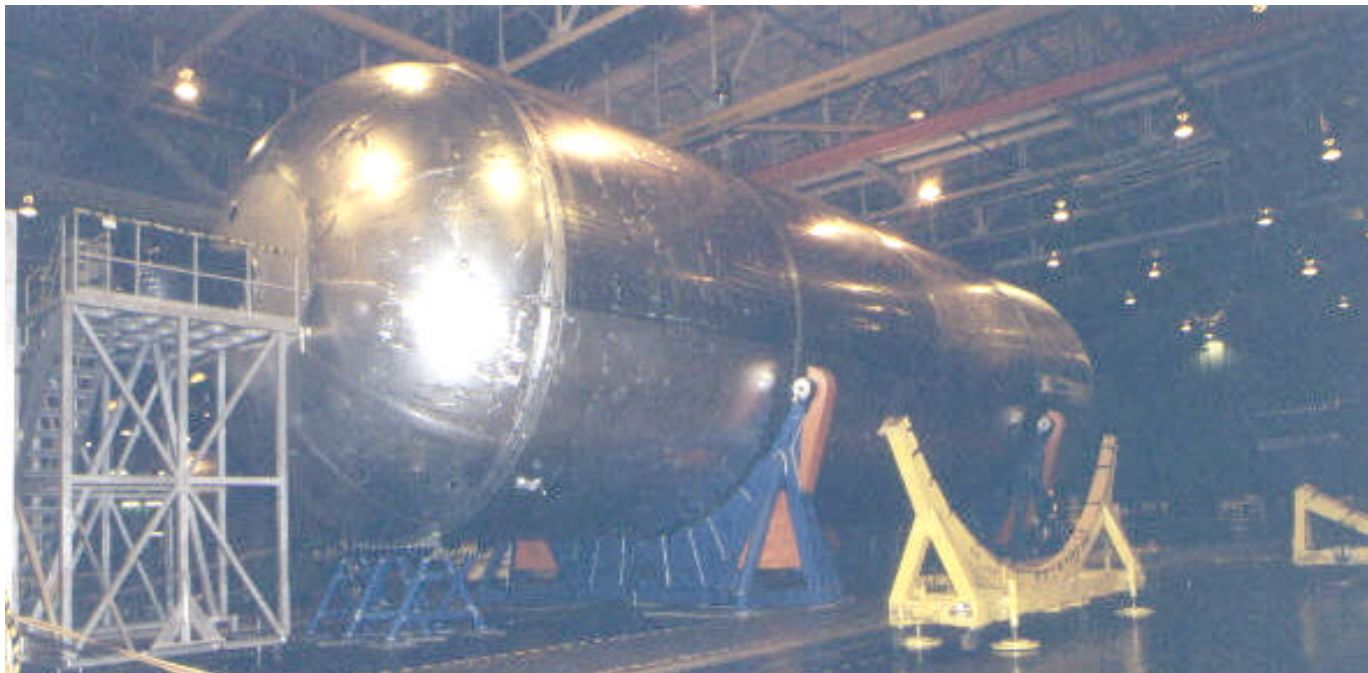
- **Potential Cause Scenario #2**
 - **Inadvertent Object Obstruction During Tank Rotation in Major Weld Tools**
 - An object is accidentally located against the tank
 - The object must be smooth and have sufficient stiffness and cross-sectional area to affect two ribs without permanently deforming the tank OSL
 - The object obstructs the tank rotation causing deflection of the tank wall resulting in cracked ribs
 - The load required to crack the ribs is estimated at approximately 1000 to 3000 pounds

Inadvertent object obstruction during tank rotation
could result in circumferential rib cracking.

- Inadvertent Object Obstruction During Tank Rotation in Major Weld Tools
